National Transportation Safety Board Aviation Accident Preliminary Report

Location:	Las Vegas, NV	Accident Number:	ERA22FA318
Date & Time:	July 17, 2022, 12:04 Local	Registration:	N97CX (A1); N160RA (A2)
Aircraft:	Piper PA 46-350P (A1); Cessna 172N (A2)	Injuries:	2 Fatal (A1); 2 Fatal (A2)
Flight Conducted Under:	Part 91: General aviation - Personal (A1); Part 91: General aviation - Instructional (A2)

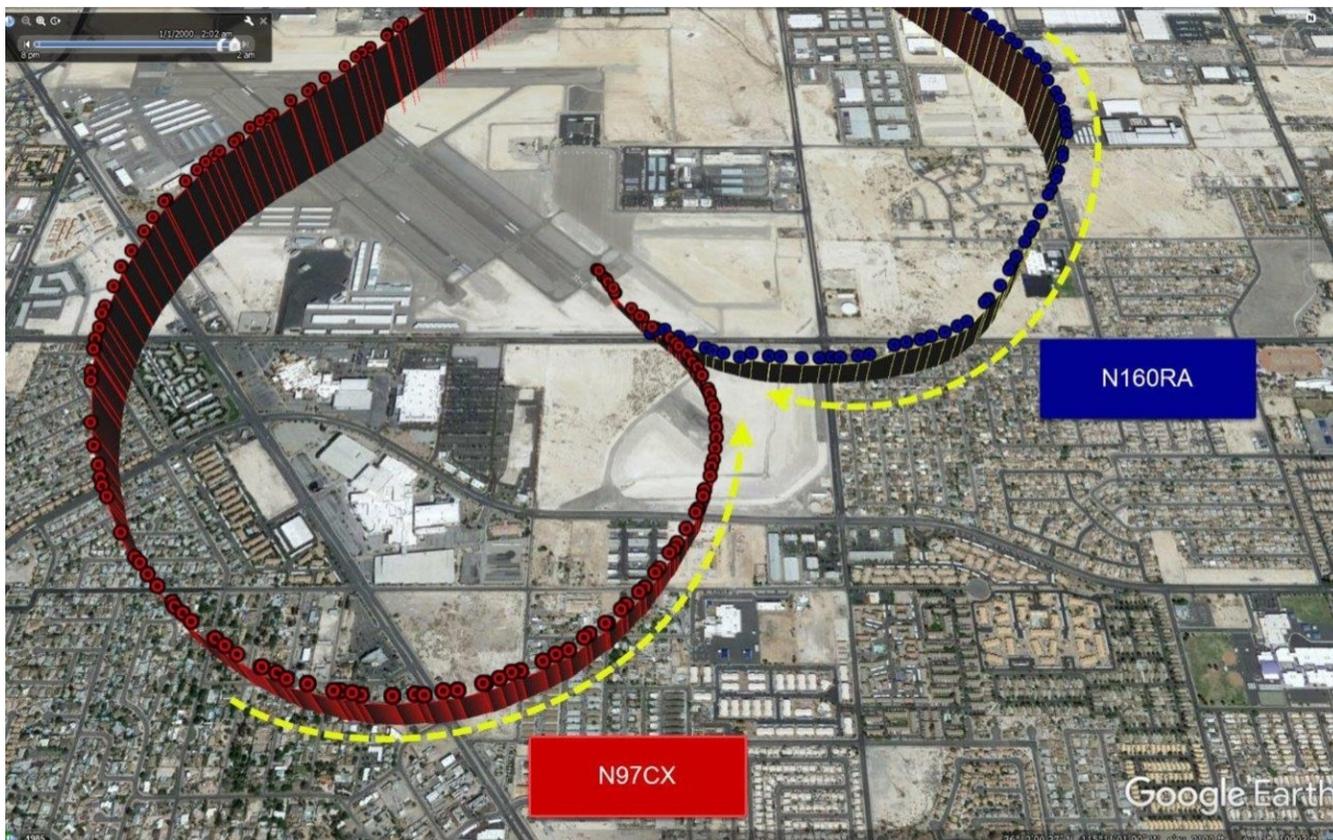
Both airplanes were maneuvering to land at North Las Vegas Airport (VGT), Las Vegas Nevada, when the accident occurred. N97CX had been instructed by air traffic control (ATC) to fly left traffic for runway 30L and N160RA had been instructed to fly right traffic for runway 30R. The airplanes collided about 0.25 nautical miles from the approach end of runway 30R. Figure 1 shows a simplified flight path diagram for the accident flights based on Federal Aviation Administration Automatic Dependent Surveillance – Broadcast (ADS-B) data.

Figure 1. ADS-B Flight Paths for N97CX (PA-46) and N160RA (Cessna 172)
