# National Transportation Safety Board Aviation Accident Final Report

<b>Location:</b>	Warm Springs, Oregon	<b>Accident Number:</b>	WPR21LA082
<b>Date &amp; Time:</b>	January 9, 2021, 13:37 Local	<b>Registration:</b>	N3RB
<b>Aircraft:</b>	Cessna 560	<b>Aircraft Damage:</b>	Destroyed
<b>Defining Event:</b>	Medical event	<b>Injuries:</b>	1 Fatal
<b>Flight Conducted Under:</b>	Part 91: General aviation - Personal

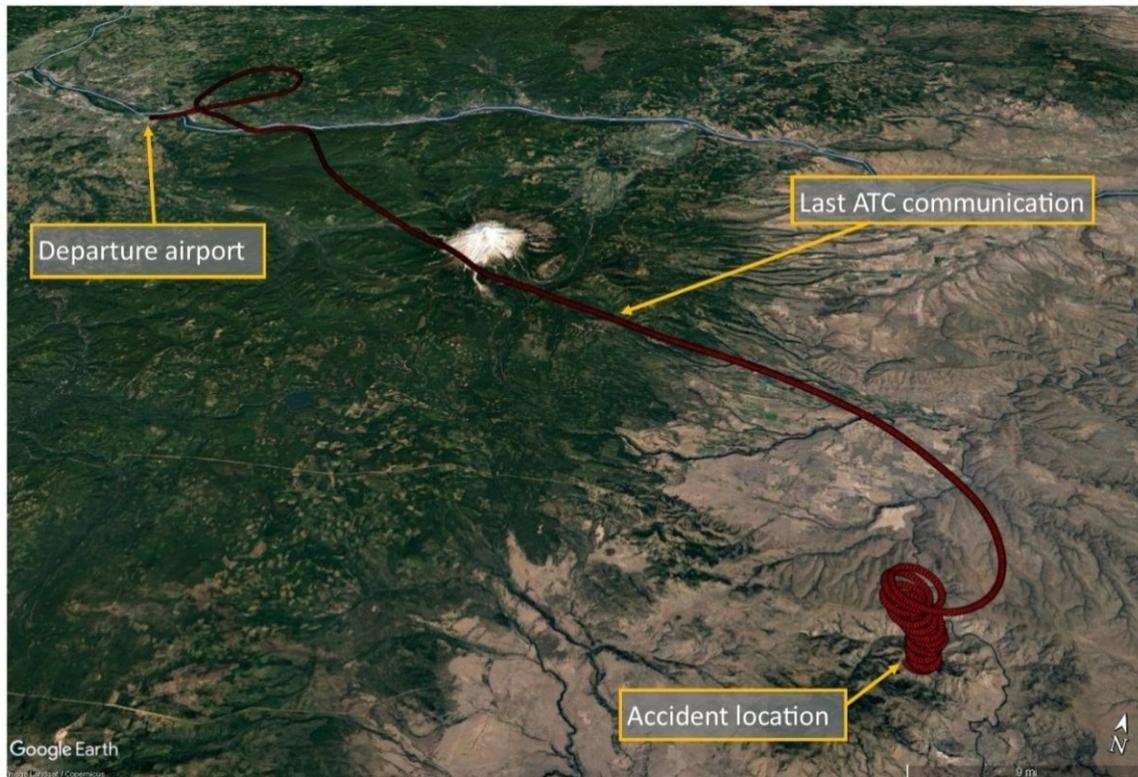
Figure 1 – Flight track

At 1327, the airplane had reached an altitude of 27,000 ft when it began to deviate to the right while continuing to climb. The controller alerted the pilot that he was about 30° right of course, but the pilot did not respond. The airplane continued to climb until 1328:45, when it reached its highest altitude of 31,000 ft. The airplane began to descend and remained for the next eight minutes in a spiraling and descending 1-mile radius right turn. (see Figure 1.) The last ADS-B

target was recorded at 1336:27, with the airplane on a northwest heading at an altitude of 3,800 ft.

Interpolation of the ADS-B data during the spiraling descent indicated a right bank angle of between 60° and 70° and a descent rate of between -2,500 to -5,000 ft/min to impact.

The data also revealed 50- to 100-knot oscillations in groundspeed during the descent. The data was compared to flight test data for the Citation 560 series airplane, specifically the data used to simulate the longitudinal, open-loop, long period (or phugoid) response of the airplane after a pitch disturbance.
