Aviation Investigation Final Report

Location:	Hanover Township, Pennsylvania	Accident Number:	ERA23FA045
Date & Time:	October 29, 2022, 14:52 Local	Registration:	N964RS
Aircraft:	Bearhawk Patrol	Aircraft Damage:	Substantial
Defining Event:	Collision with terr/obj (non-CFIT)	Injuries:	2 Fatal
Flight Conducted Under:	Part 91: General aviation - Personal

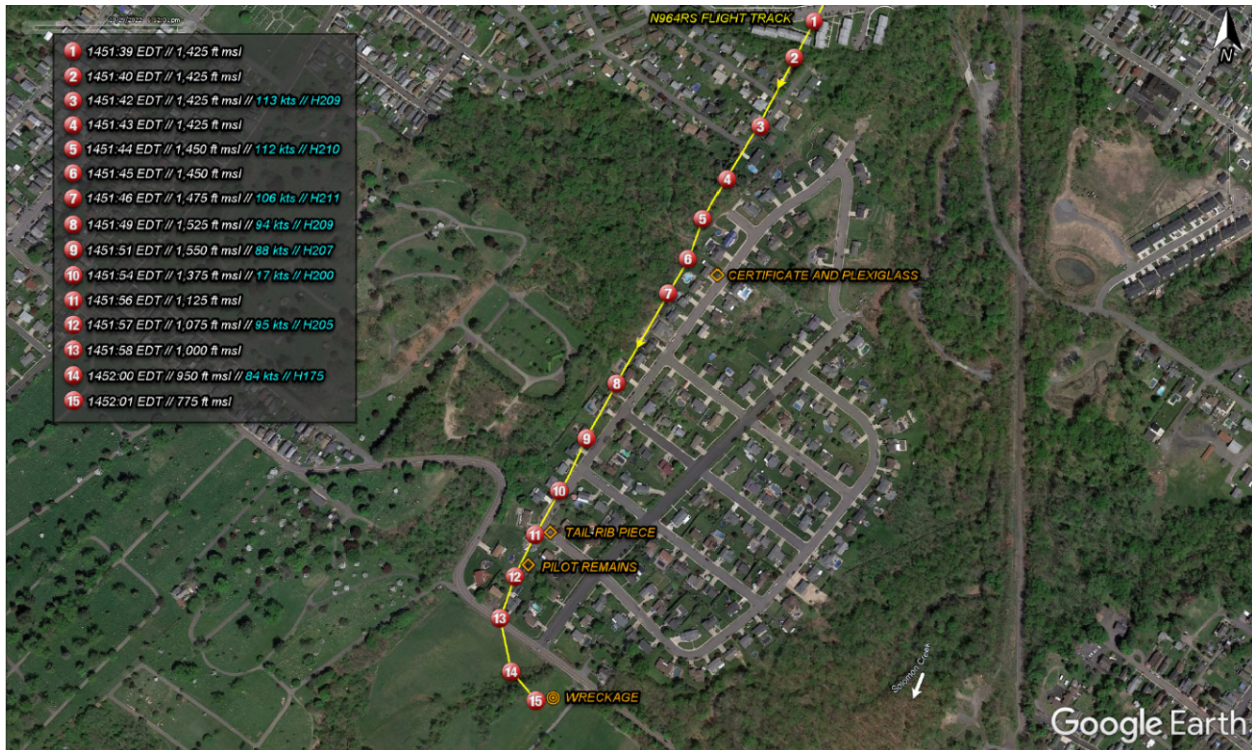
The airplane impacted a grass field about 5.2 nautical miles southwest of WBW. A linear ground scar, consistent with the length of the left wing, extended from the center of the wreckage with the scar oriented toward a magnetic heading of 338°, and the wings came to rest oriented on a magnetic heading of 319°. All major airplane components were located on site; however, paint chips, the airworthiness certificate, and portions of the cockpit ceiling or side window Plexiglas were the first items along the 1,900-ft-long debris path leading to the main wreckage, followed by a portion of a tail rib at 900 ft and the pilot at 530 ft from the main wreckage (see figure 1.)

Figure 1 - Flight path (yellow line) with annotated position, time, altitude, ground speed, and path heading. The locations of recovered debris are also plotted.
