The Ten Month
Restoration of...

NC33NA

By "Team Waldo":
Rob Lock, Lisa Heidinger and
Roger Brown

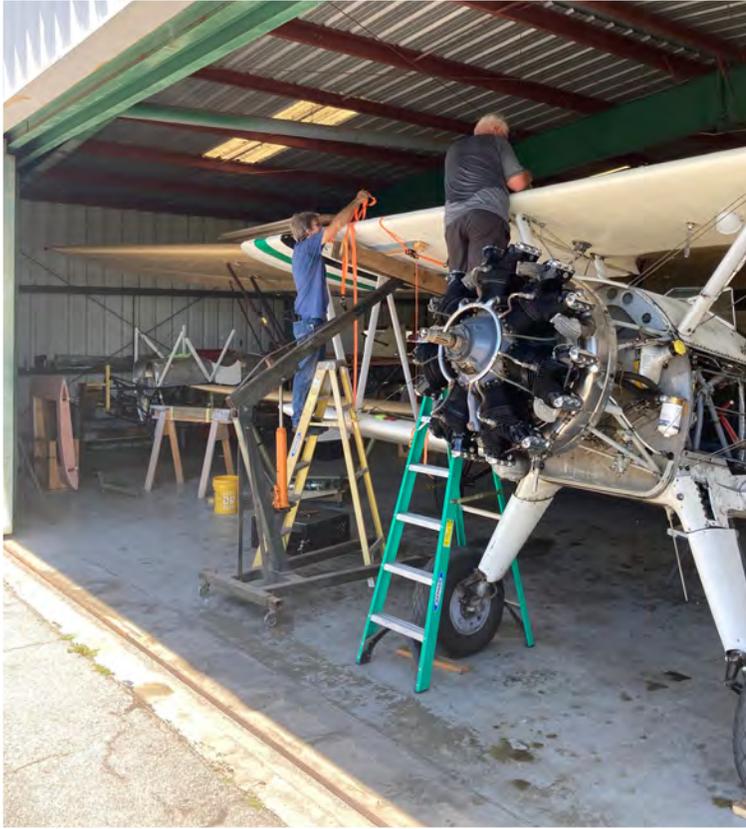
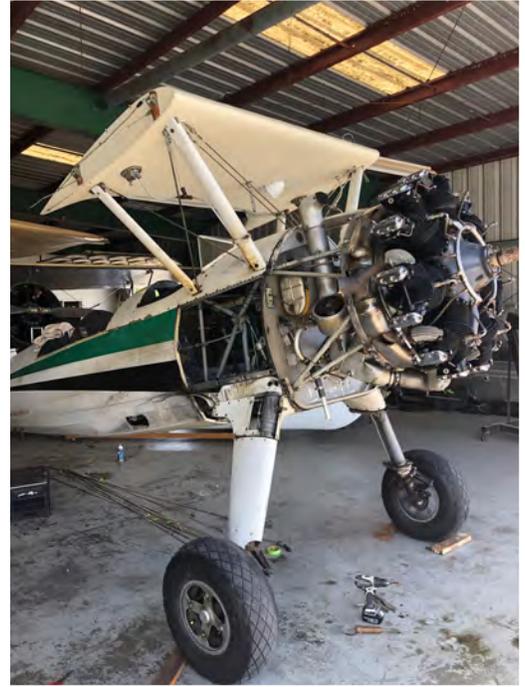
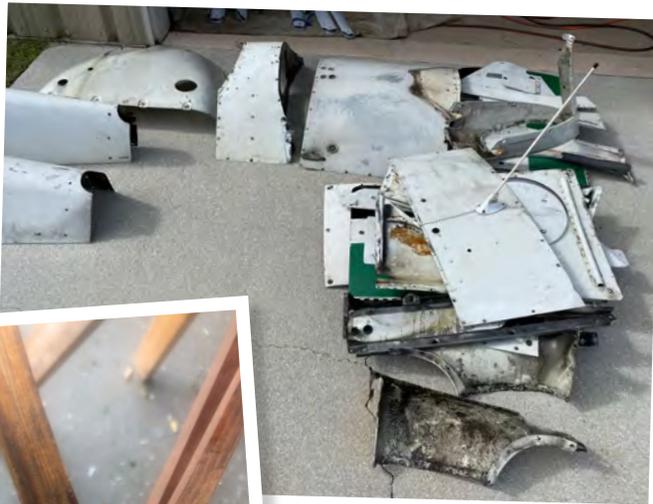
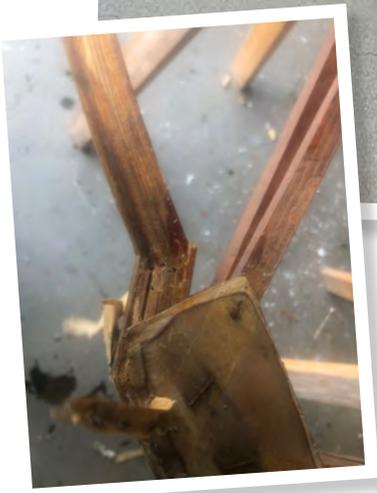
- DISASSEMBLING NC33NA -

After landing at Waldo Wright's Flying Service on August 5 of last year, the team immediately went to work tearing the plane apart. In less than a week, all major components, such as wings, center section, tail group, birdcage, sheet metal and firewall forward were removed. All fabric was removed from all components. The sheet metal and parts such as the wing struts, went to the owner, Roger Brown's hangar, near Fort Pierce, Florida. There, it would all be stripped of paint, repaired and painted in epoxy primer. The engine was stripped of most accessories, such as exhaust, intake, linkages, hoses, mount, etc. Everything was detailed before going back together. Some damage was found under the fabric covering. Pictured are a rotted wing walk on the lower right and a broken bow on the upper left.

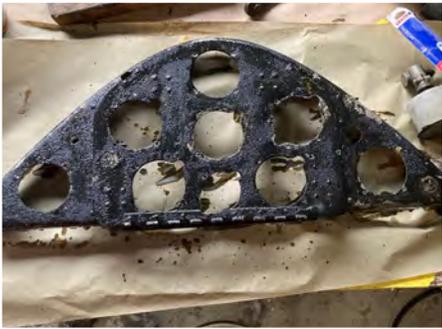
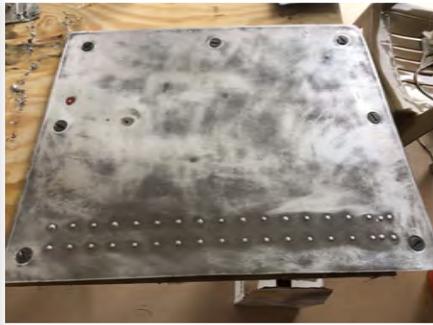
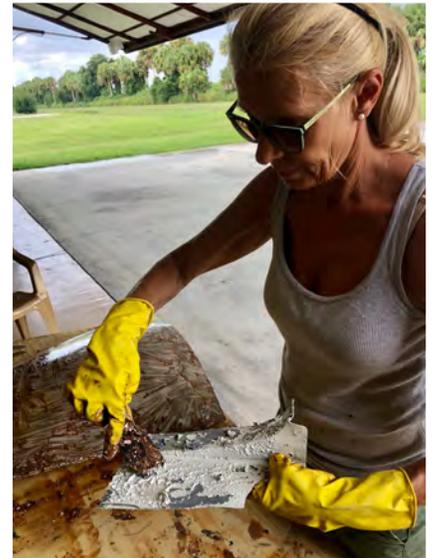
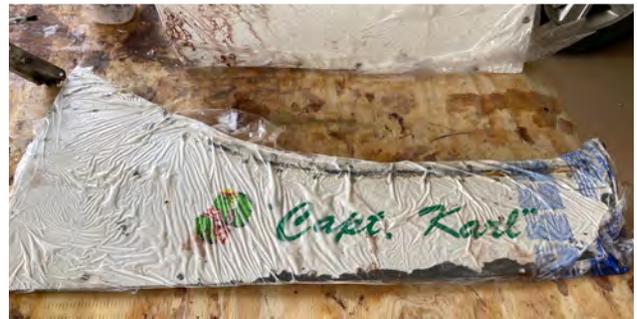
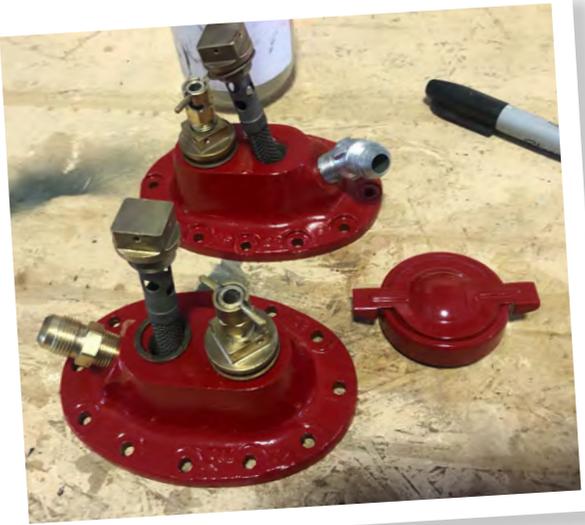
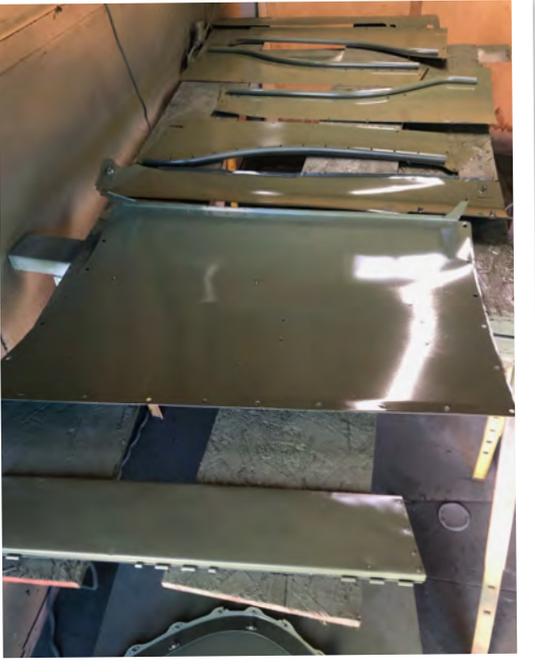
Team Waldo member, Lisa Heidinger spent weeks last summer stripping paint from sheet metal panels, parts, wing struts, seats and more. She became very good at it, using an environmentally friendly stripper and a power washer. Hundreds of small parts were salvaged, bead blasted and plated with cadmium. Other small wing parts were stripped and painted with epoxy primer before being reused in the new wings. The seats were carefully stripped. One wood seat still had the manufacturer's label under several coats of paint. The label was preserved.

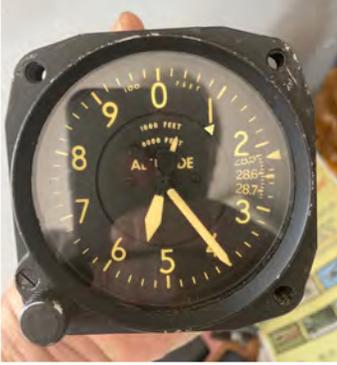
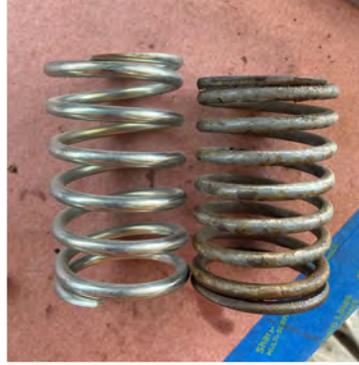
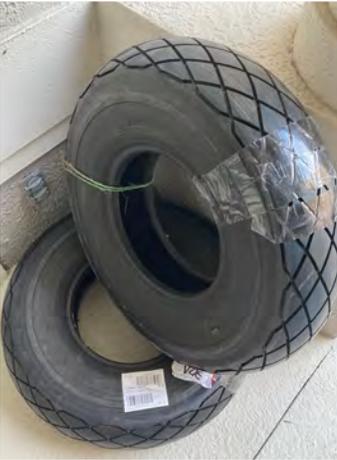
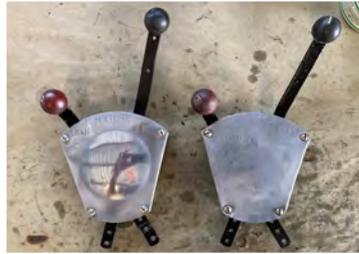
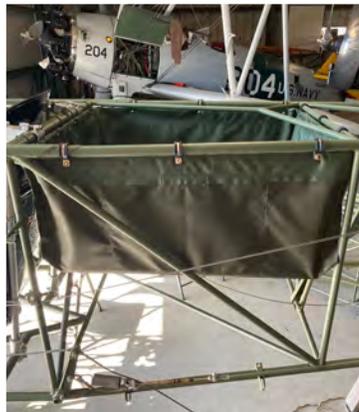
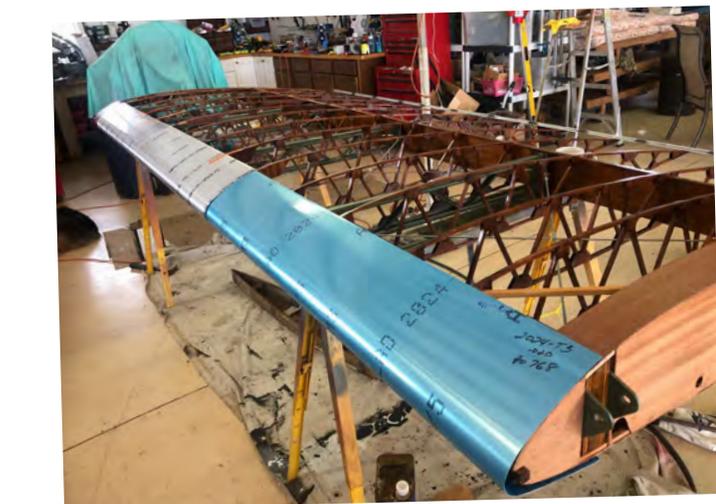
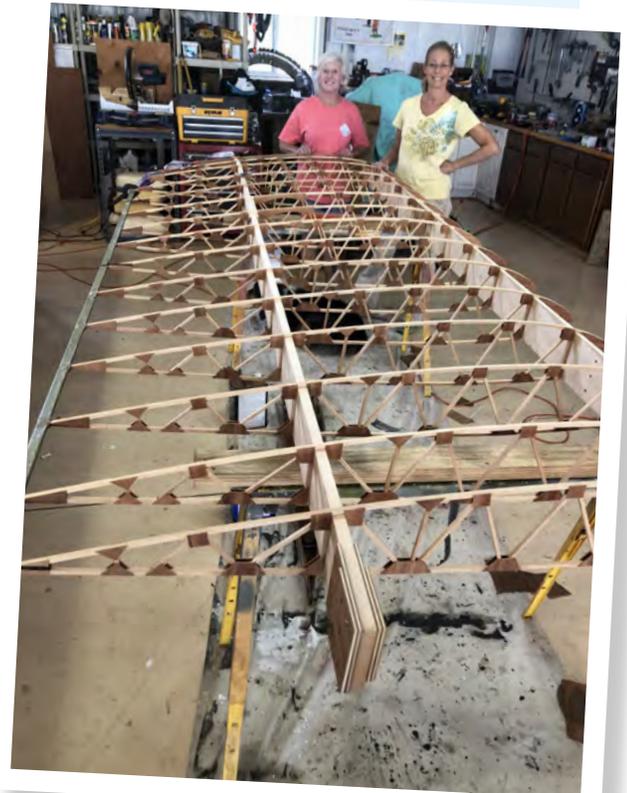
- NEW STUFF -

Not everything was salvaged. All new control cables were purchased from Yesteryear Aviation. New floorboards were made from mahogany plywood. Correct throttle quadrants we're sourced. New seat belts and harness came from Hooker. All new tires were purchased. Many new wing pieces were obtained, to include all new leading edges. A brand new baggage compartment was ordered. The upper left wing was completely NEW... with spars, ribs and leading edges coming from Yesteryear Aviation. A new stainless steel firewall was installed. Several "correct" instruments were sourced. Every nut, bolt, cotter pin, spring, bushing, bearing and screw is NEW! The list goes on, but you get the idea.

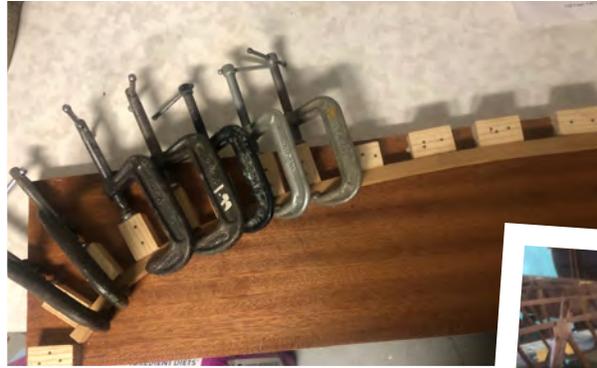
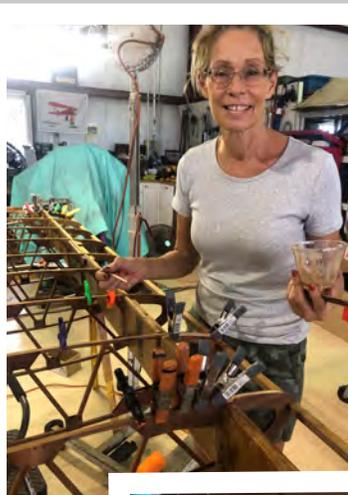
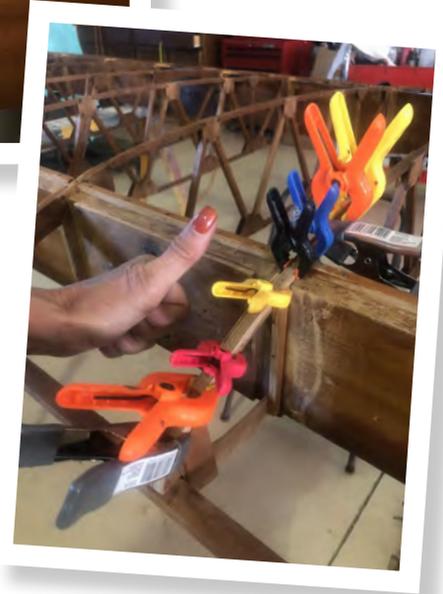
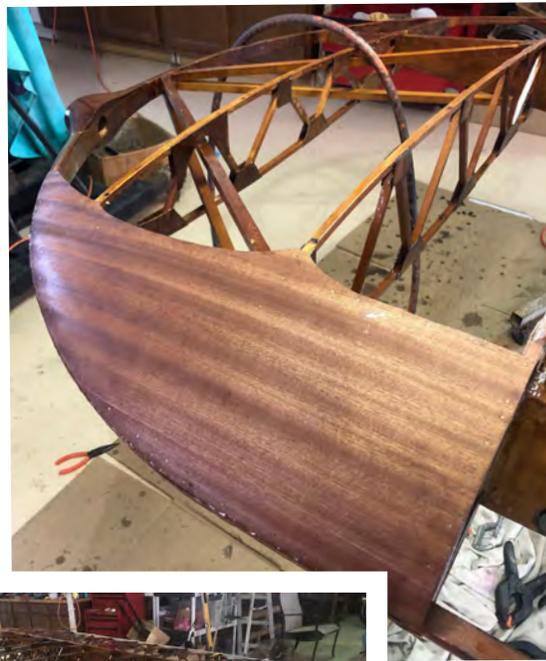
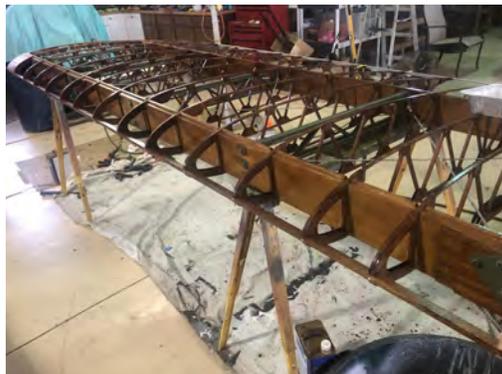
- WOODWORKING -

The most difficult was the lower right. This was a Dusters and Sprayers built wing. It was almost new when Brown purchased the aircraft in 1990. Again, a thorough inspection revealed a perfectly good

wing, with the exception of the inner three ribs and the wing walk area. Moisture had created a rot situation that had to be rectified. New ribs and wing walk materials were sourced from Yesteryear. All hardware was removed, stripped and painted. Every rib gusset was inspected and repairs made where needed. The wing was assembled, hardware reinstalled and it was trammed and varnished. New leading edges were installed and it too went off to Winter Haven.

There is a lot of wood in a Stearman. All the wood work was performed at Brown's hangar. The lower left and center section were purchased new, from Yesteryear Aviation just a few years ago. They were covered in poly fiber and painted through white Polytone. These two components were prepped and painted to match the rest of the aircraft in Polytone's "Glacier White".

Both upper wings were deemed to be beyond use, to include the spars. A Stearman friend, Jim Lyons, donated an upper right wing to the project. It had been built some time ago, with new ribs, using original spars. A thorough inspection revealed that it was in very good condition and definitely airworthy. Three nose ribs were broken from years of storage. Lisa went to school on those repairs. New ribs were constructed and installed using approved scarf joint methods and glues. All hardware was removed and painted. The hardware was then reinstalled and the wing was squared and trammed. Two coats of epoxy varnish were applied and new leading edges installed. The wing went off to Winter Haven for fabric covering.

Next up was the upper right. This one was all new construction with spars, ribs and leading edges coming from Yesteryear. Construction of this was almost easy, compared to rebuilding the other upper. This one was soon off to Winter Haven for fabric.

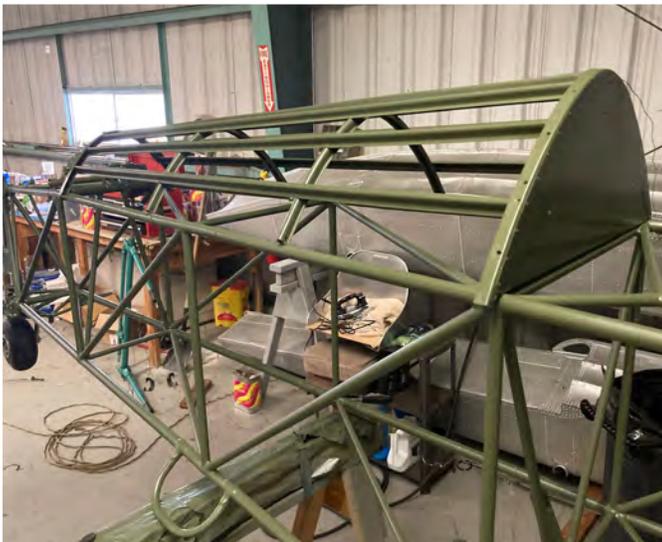
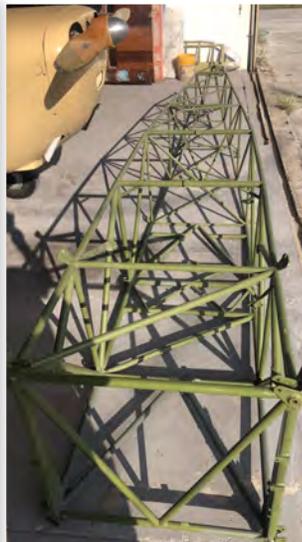
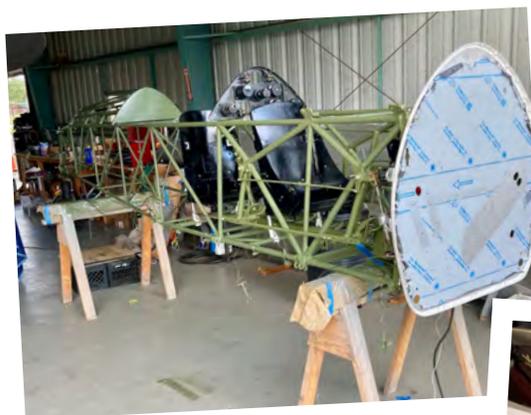
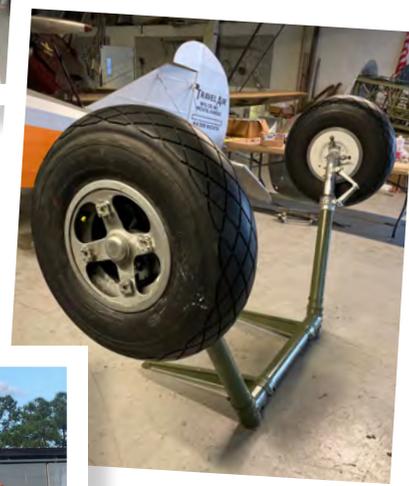
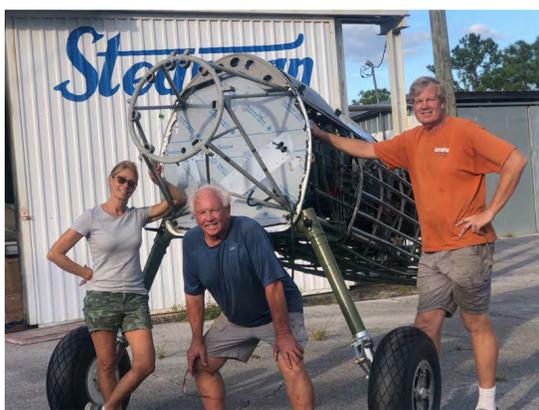
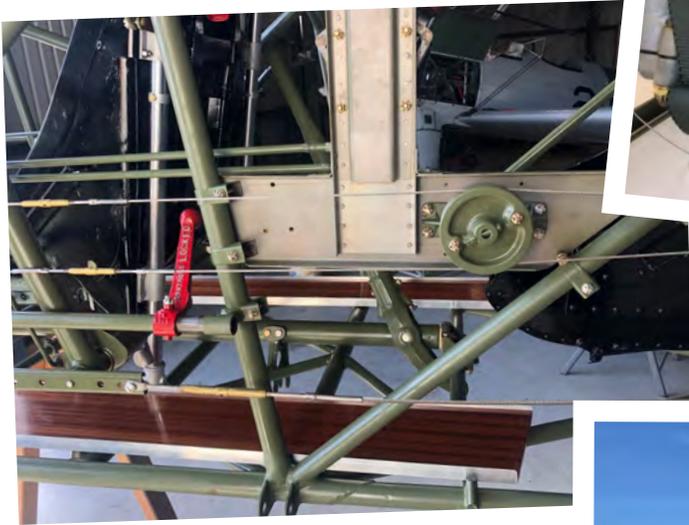
There is a LOT of fabric covering on a Stearman. Poly Fiber was the process used on this project. All the fabric was taken through a Polytone finish in Glacier White. All the fabric work and finishing was performed at Waldo Wright's Flying Service in Winter Haven, Florida. Roger Brown and Lisa Heidinger assisted Rob Lock when covering and stitching larger components such as wings and the fuselage. Rob did all the spray work. Lisa and Roger often helped with sanding the Poly Spray coatings.

In the accompanying photos, you'll see much of the process. Some are quite humorous, if aware of the back story. For instance, Brown's early attempts at mastering the "Rib Stitch" were hilarious. He FINALLY figured it out. When looking at the photos, you notice Rob's meticulous attention to detail... the straight tapes... even spacing... intricate patches... and NO curled pinks!!!

Overall, the fabric work on this project is near perfect!

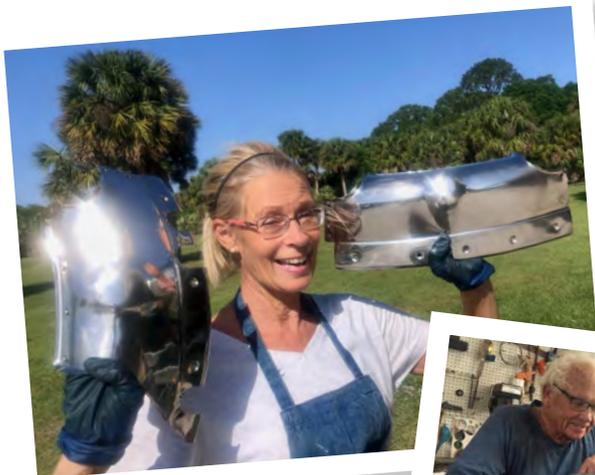
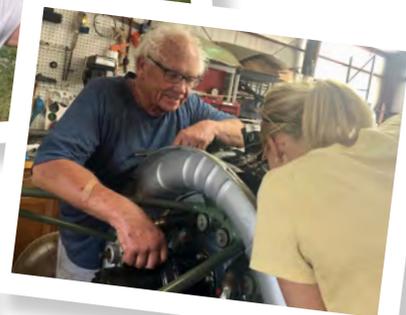
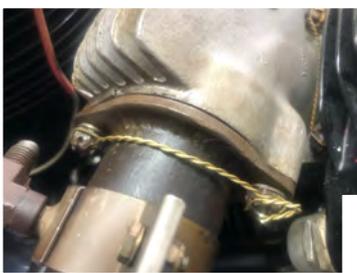
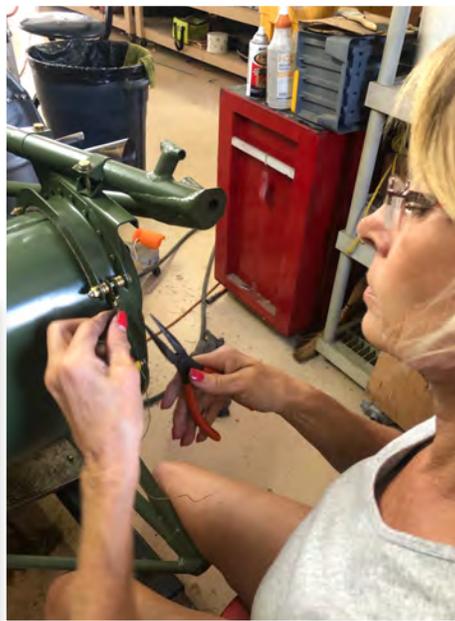
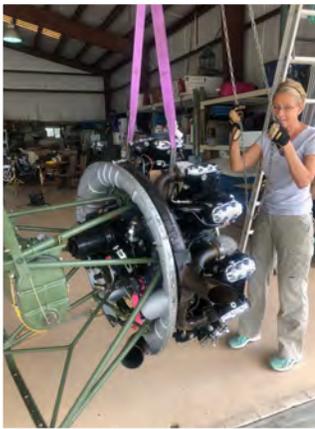
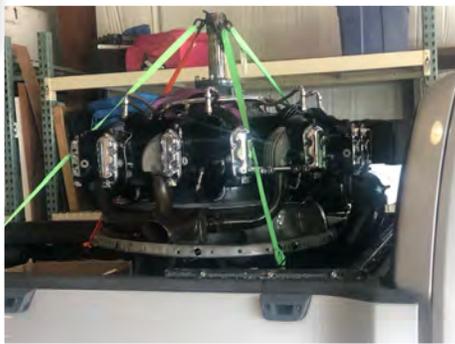
- FIREWALL -

Early in the process, the engine, along with the mount, accessories induction system and oil tank were taken to Brown's. The engine was placed in a custom stand where much was removed for cleaning, painting, detailing, etc. Besides the listed components, the exhaust systems, shrouds, baffles and dishpan were removed. Everything went back together before transport to Winter Haven in the spring. Once back on the airframe, the engine was timed, a compression test was conducted and the valves adjusted with new gaskets on all valve covers.

Also, a new stainless steel firewall was purchased from Yesteryear Aviation. The original outer ring was removed from the old firewall by drilling all the rivets. It was then epoxy painted and riveted to the new firewall.

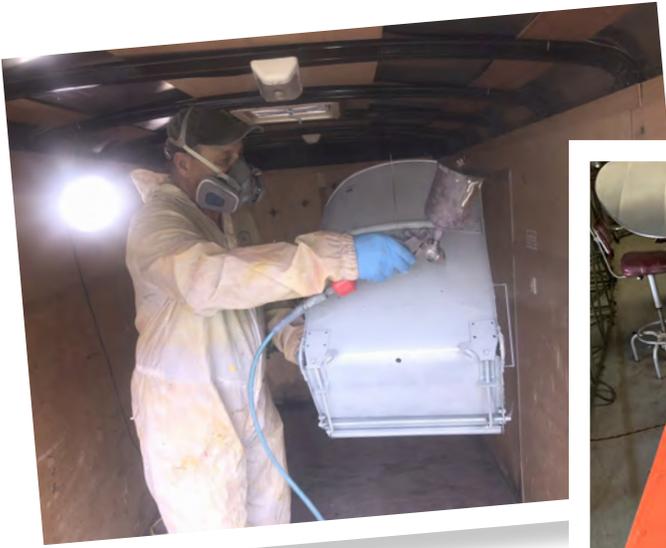
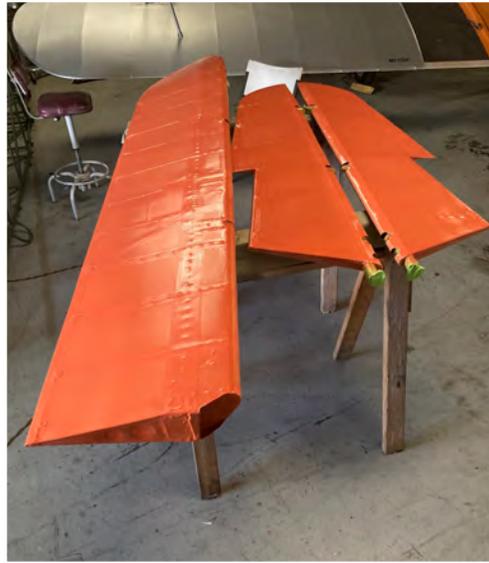
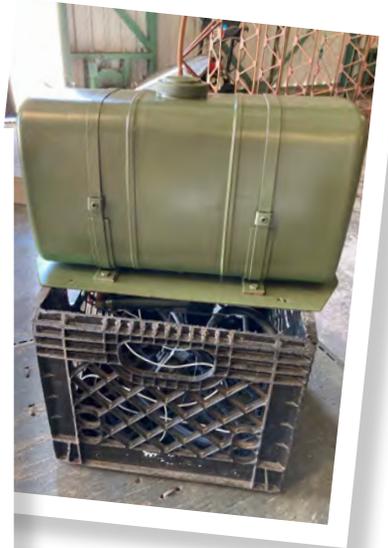
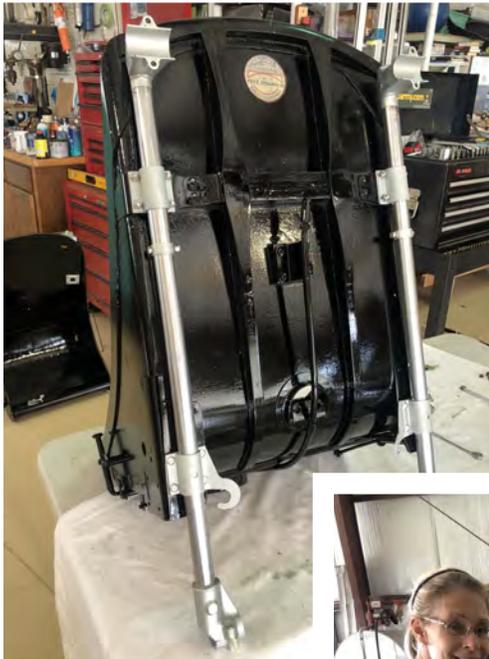
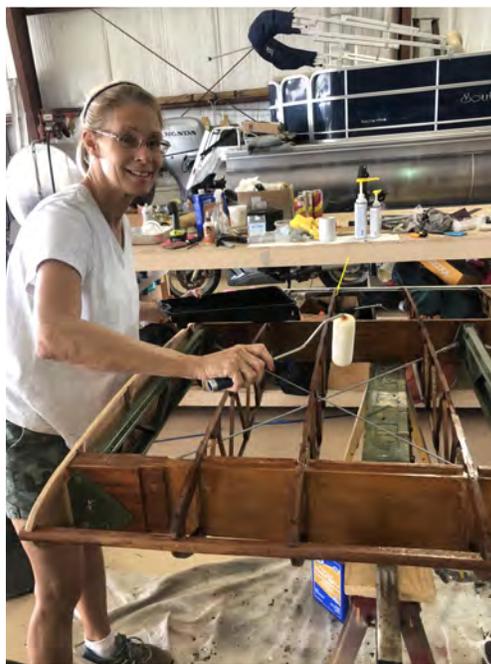
- PAINT & VARNISH -

Again... a LOT of paint, varnish and a variety of finishes go into a Stearman restoration! Many metal parts were cad plated. Most parts were at least stripped, sanded cleaned and sprayed with epoxy primer. Other pieces, anything that shows, received finish coats of white. All fabric surfaces are coated in various layers of Poly Brush, Poly Spray and Polytone paint. Some areas even have additional coats of green or black Aerothane. All wood work in the wings received two liberal coats of epoxy varnish. Other parts, such as instrument panels and seats got special paints. Lastly, a custom sign painter added finishing touches of hand painted artwork and lettering. Smaller pieces, like fuel sumps and oil fill caps were painted in appropriate colors.

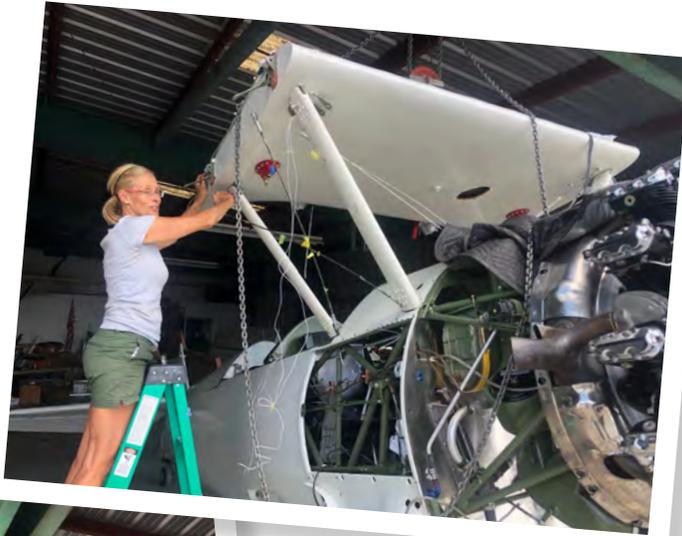
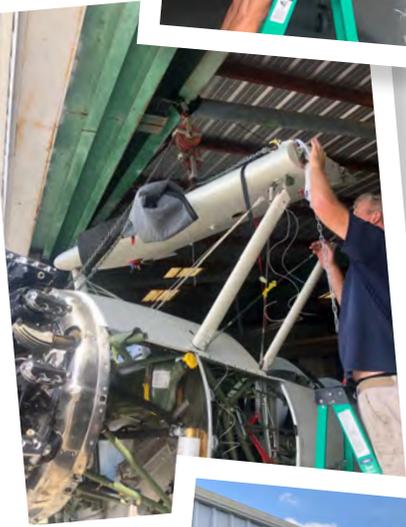
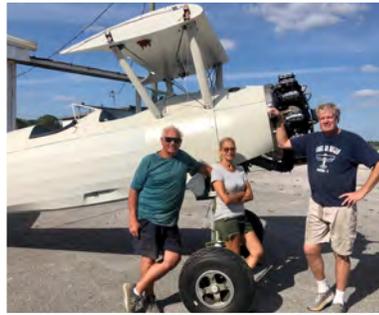
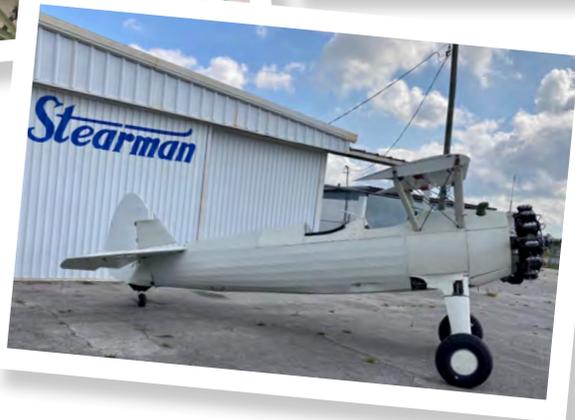
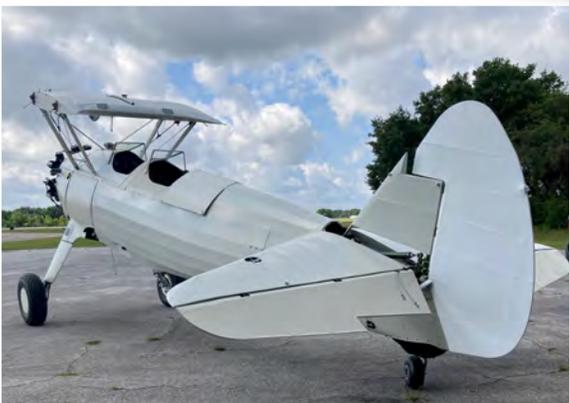
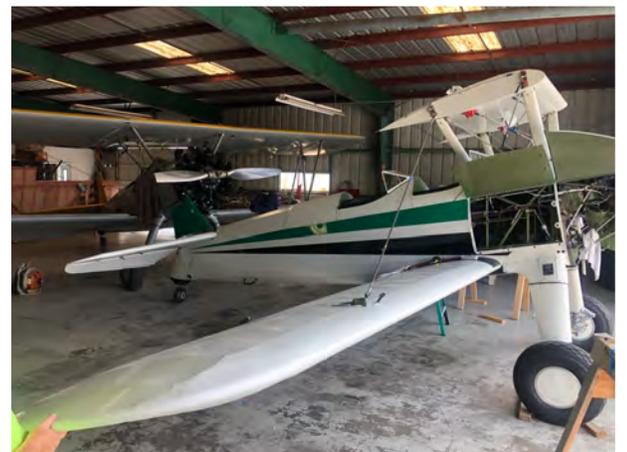
- FINAL ASSEMBLY & RIGGING -

The final assembly of major components had NC33NA looking like an airplane again. Once the fabric work was done on the fuselage and the green and black stripes painted in Aerothane, it was time to start bolting on parts. Rob was able to install the horizontal stabilizer, elevators and vertical fin. Lisa and Roger showed up to help install the lower wings. When the time came to install the uppers, Brown's wife, Terese and a family friend, Hannah Dougherty were enlisted to help. The left upper went up and on with little trouble. Hannah set up her phone to video the upper right installation. It was on, and in place with the bolts in all the struts and attach points, in just 19 minutes!

Then came the installation of all the flying and landing wires. Using a custom set of incident and dihedral boards, a new digital level and Rob's WWII era tensiometer... all wings and wires were brought into near perfect tolerances. It is amazing that this collection of eighty year old parts could still be fitted together that closely!
